UNSTABLE BED AND BANKS OF THE DANUBE RIVER AT THE "APATIN" SECTOR

THREAT TO THE LOCAL COMMUNITIES, PROTECTED AREAS, AND WATER TRANSPORT ALONG THE DANUBE CORRIDOR

SECTOR APATIN

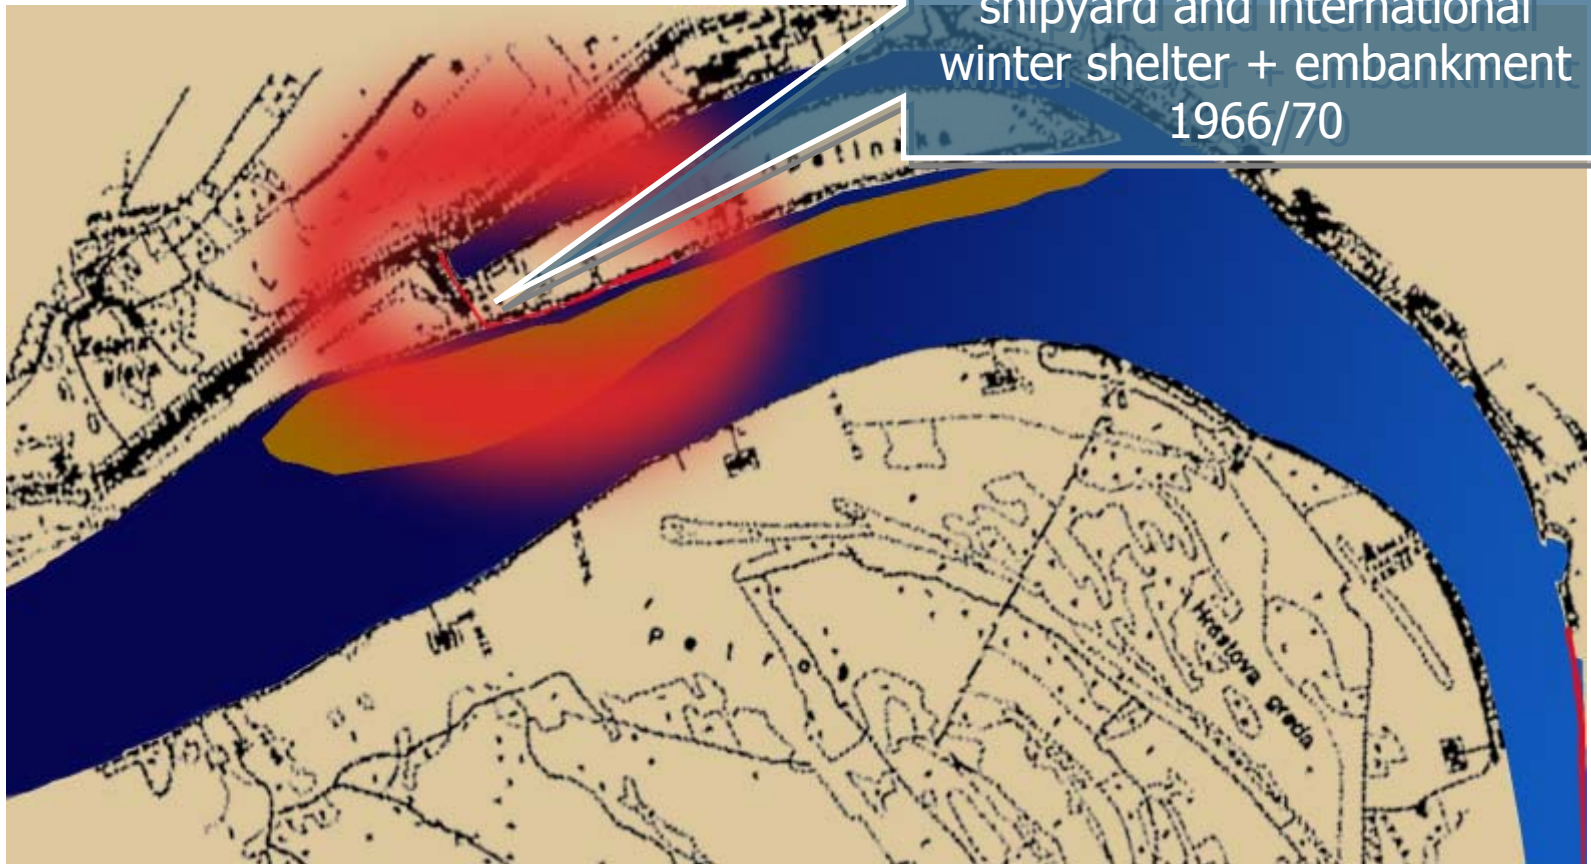
Closure dam at km 1403.6 -
the left branch of the Danube
at the Apatin isle became a
shipyard and international
winter shelter + embankment
1966/70

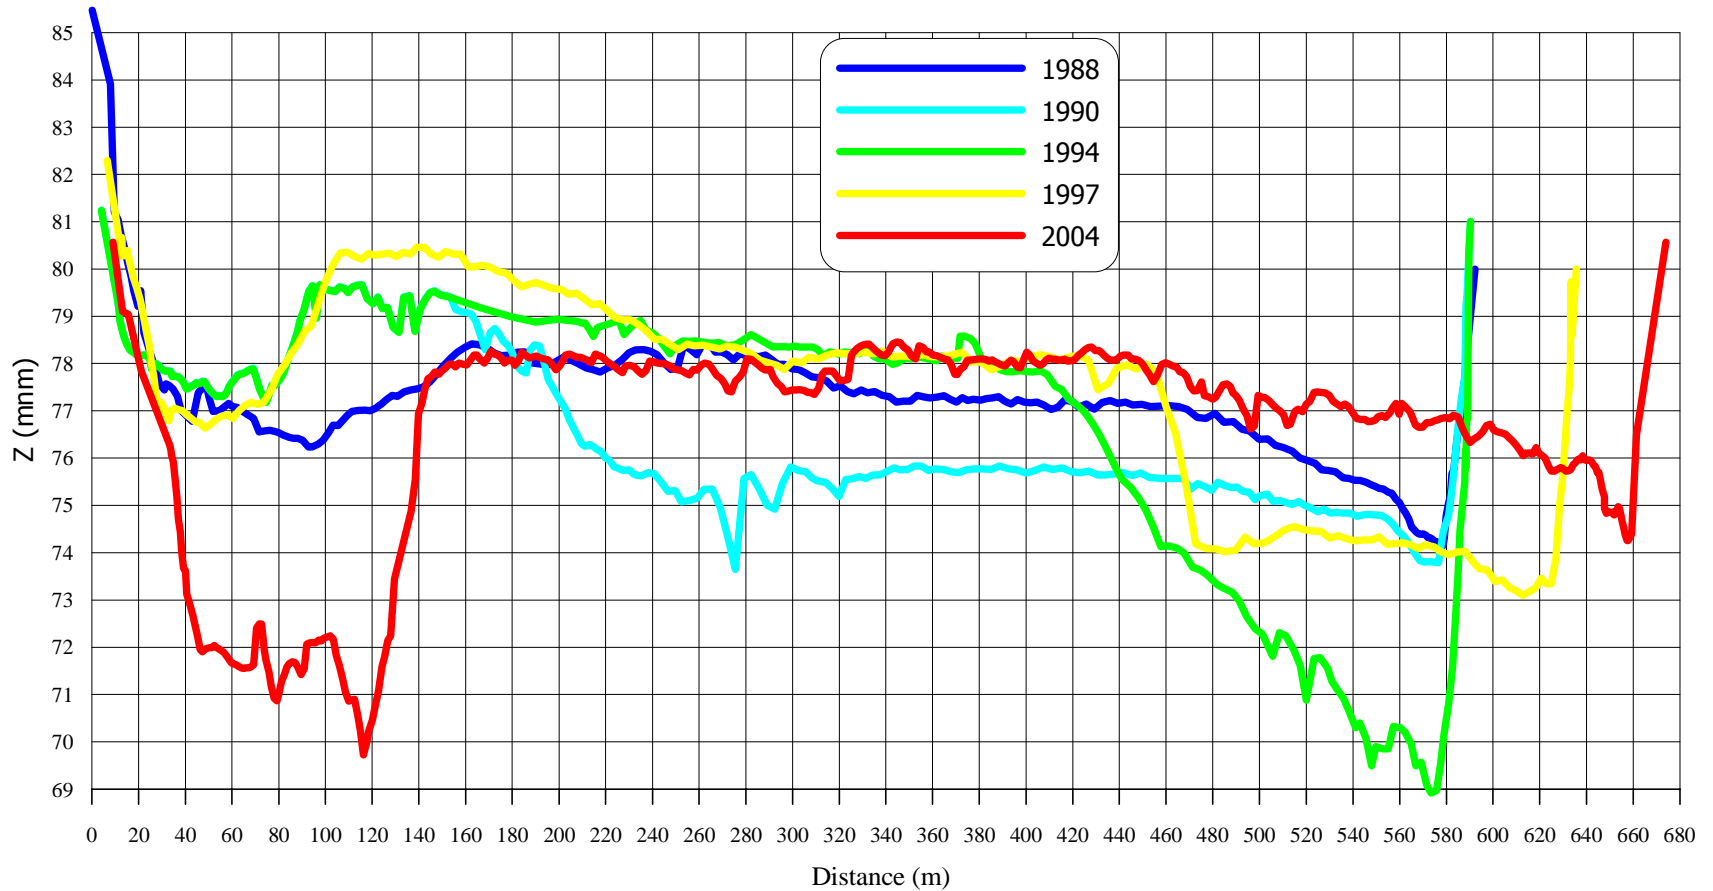
EP 24/1

EVOLUTION OF A CHARACTERISTIC CROSS-SECTION

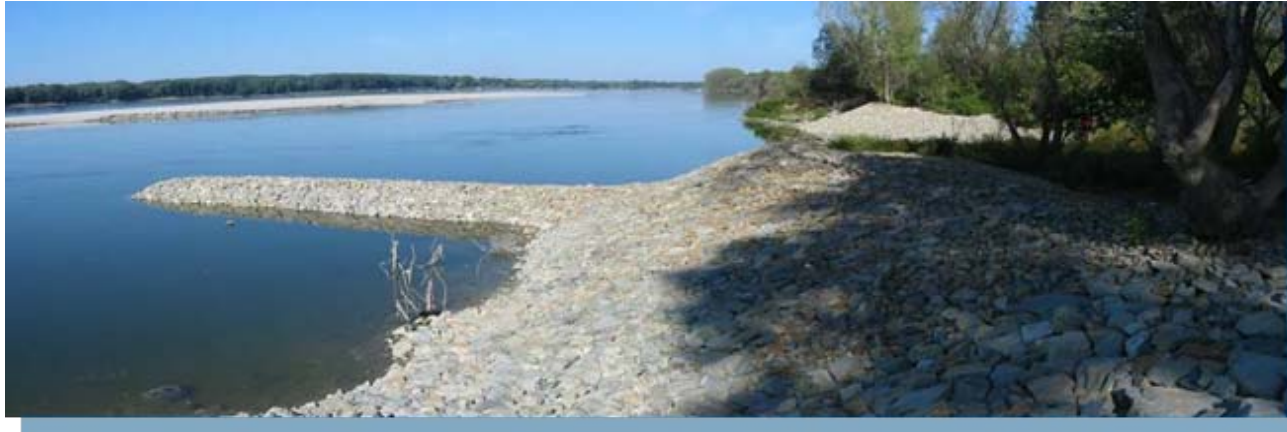
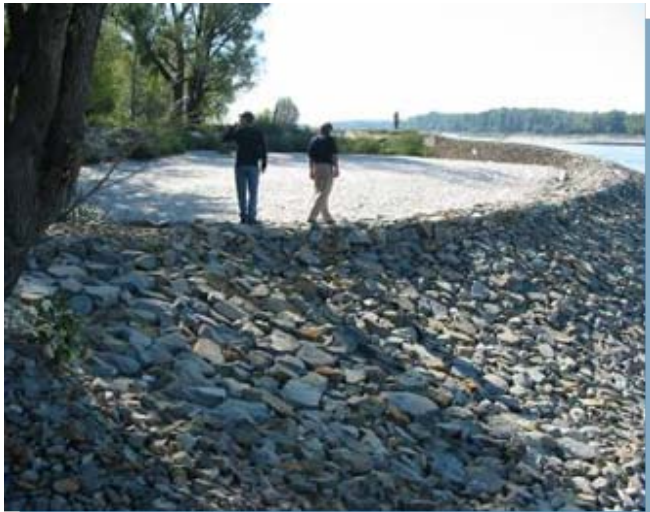
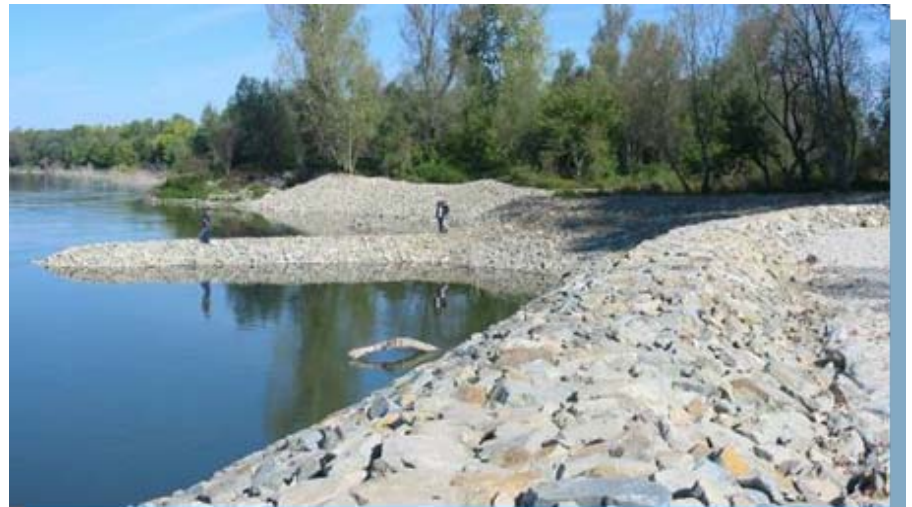
LOCAL PROTECTION OF LEFT BANK (SERBIA)

Objective: protection of Apatin city, including harbor, shipyard, international ship winter shelter, customs office, and city beach

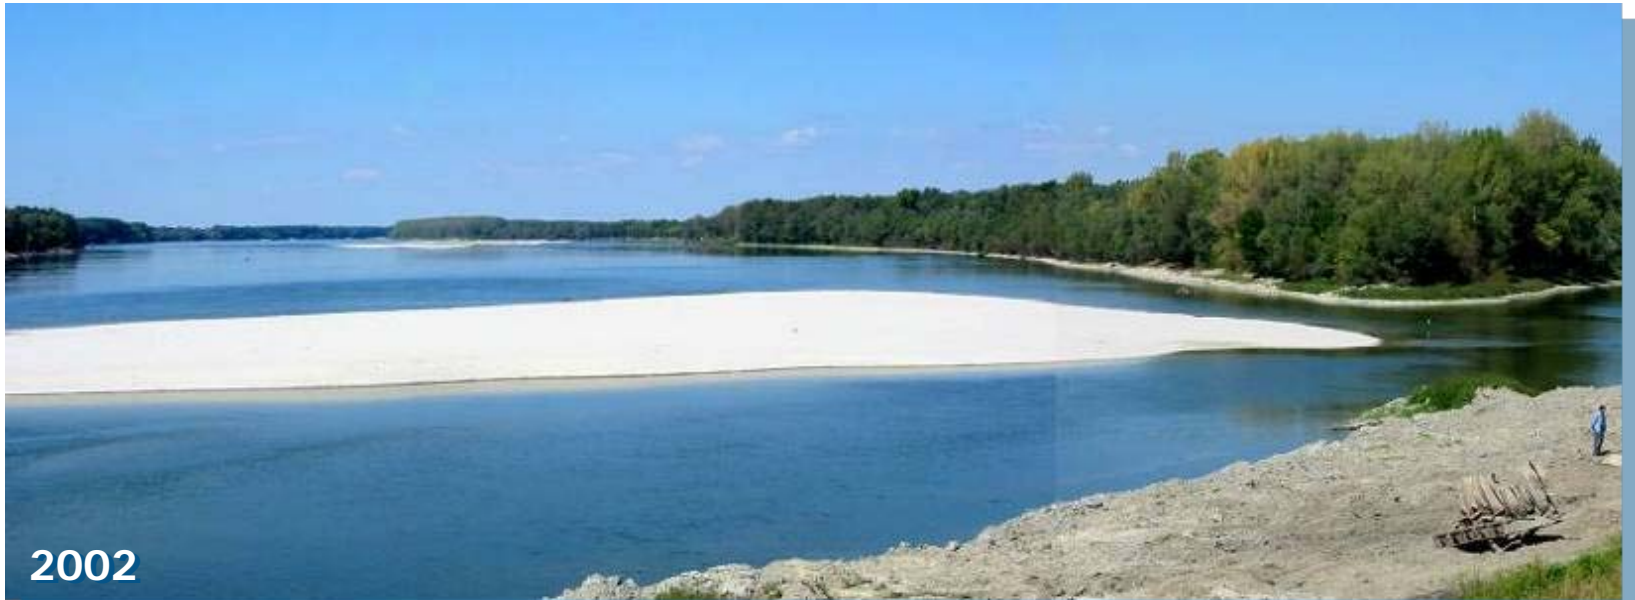
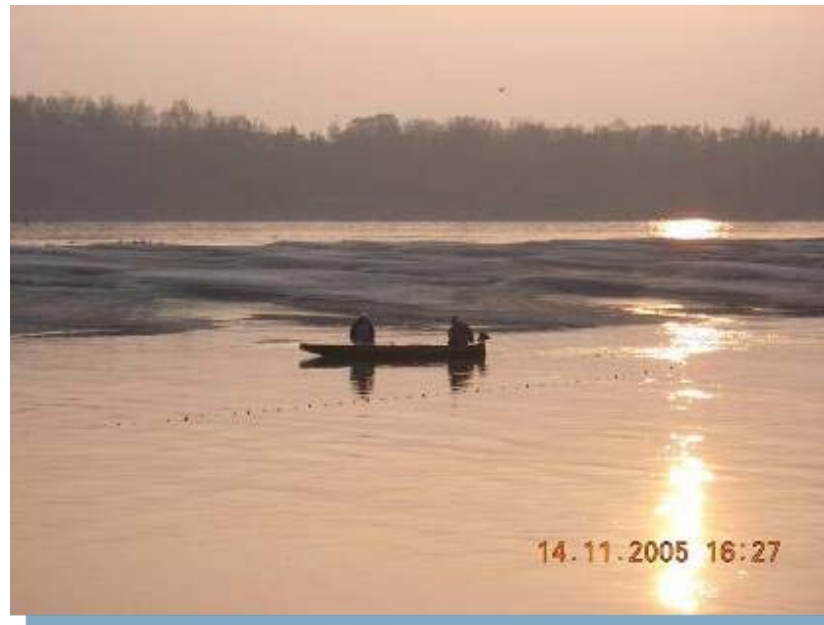
UNSATISFACTORY NAVIGATION CONDITIONS

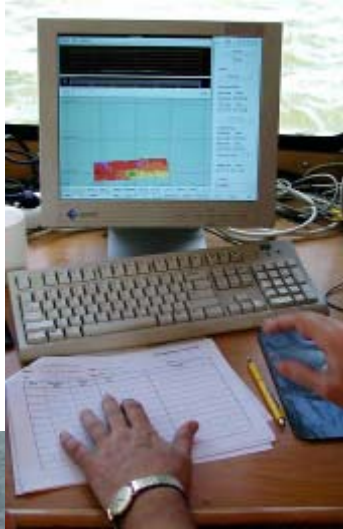
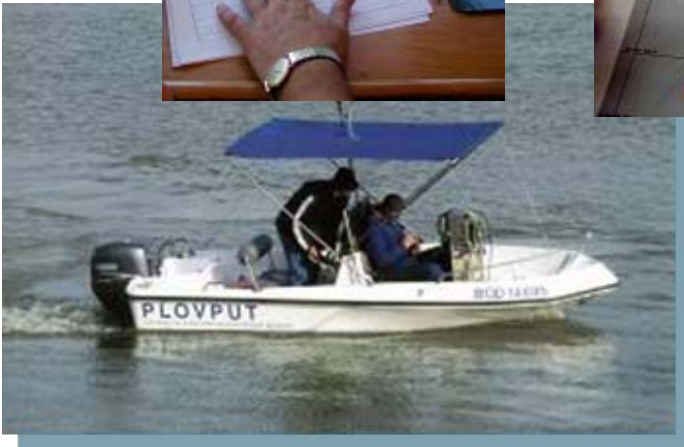
RIVERBED SURVEY km 1399 – 1406

Dec. 2004 and May 2006
120 cross sections (50 m apart)

2 SERIES OF FLOW AND SEDIMENT MEASUREMENTS AT 6 CROSS SECTIONS

- December 2004
- May 2005

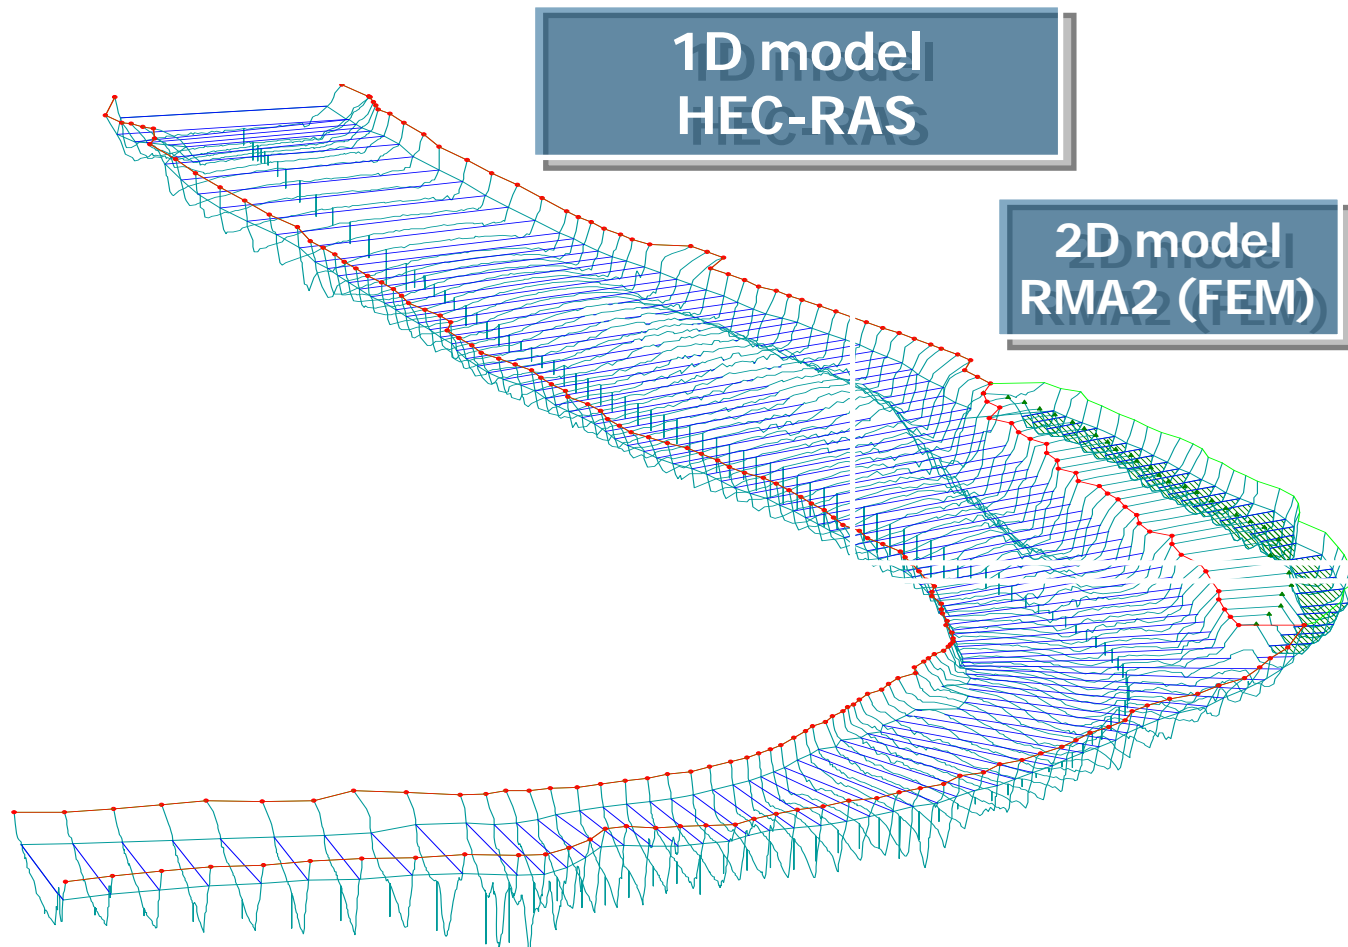
HYDRAULIC MODELING

- **model calibration and verification (data from field campaigns)**
- **analysis of the present state by numerical simulations**
- **predictions taking into account designed river training structures**
