# Safety of the Tailings Management Facilities in the Danube River Basin

## Technical Report

Capacity development to improve safety conditions of tailings  
management facilities in the Danube River Basin – Phase I:  
North-Eastern Danube countries (Danube TMF project)

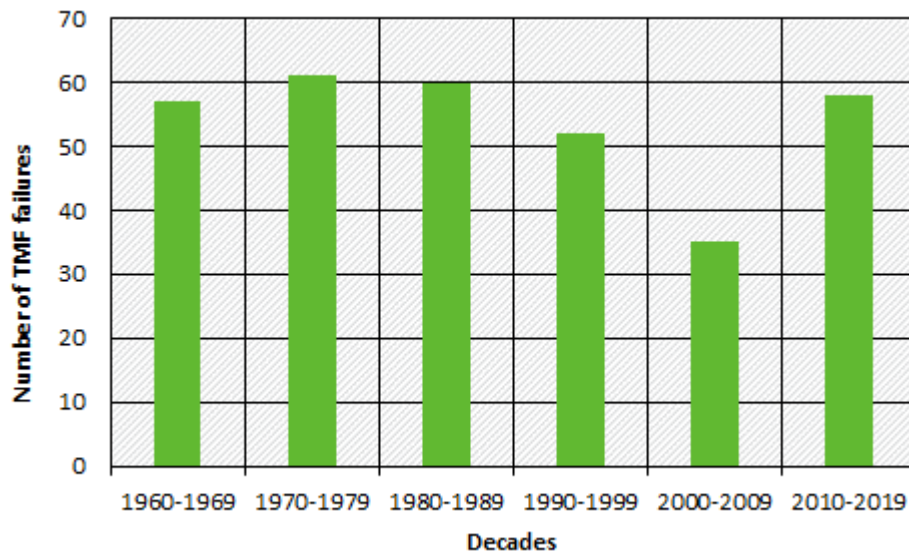
During the last 60 years, 323 accidents were reported in total. The number of failures was stagnant in the first three decades then decreased after 1990 over two decades (1990-1999 and 2000-2009), presumably reflecting to reduced mining activities between 1990 and 2009, in particular in the former Soviet Union countries. However, over the last decade the number of failures returned back to the level of the 1970ies. In 2019 alone, there were 7 TMF failures, two of which were very serious with multiple deaths. The failure trend is rising, therefore actions need to be taken to avoid a high number of serious accidents. Nevertheless, modern surveillance techniques and visual recording have become widespread in the last decade which provide sound evidence and reliable data on accidents but these tools were not available in the past therefore historic records may be uncertain. Besides this, the effects of climate change (increasing frequency and intensity of heavy rainfall, thunderstorm and flash flood events, rapid snow melt) may also contribute to this increasing tendency.

**Figure 1. Number of TMF dam failures by decades from 1960 to 2019.**

Data records over 350 failures of TMFs in the world are available since 1915. However, data sets on failures occurred before the 1960s are rather incomplete. Moreover, there are only a few reports about these failures, because the total number of TMFs was small and the operation of the TMFs was not properly documented. Therefore, only the accidents in the last 60 years were considered for the assessments (Figure 1 and Annex A).

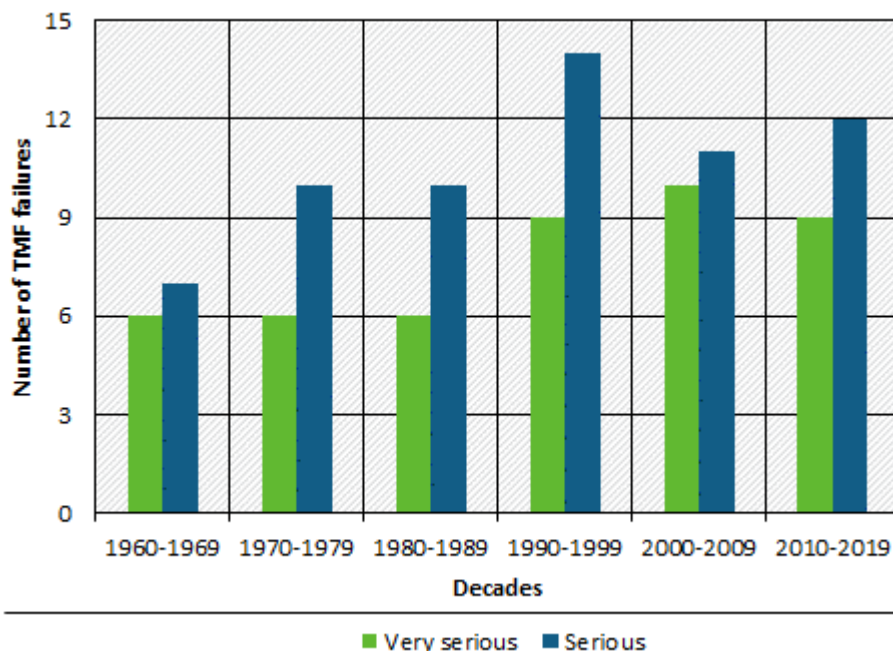
Categorizing the impacts of TMF failures is a difficult - and to some extent subjective - task. Also the line between a serious failure and a very serious failure is not clearly defined. Bowker and Chambers (2015) defined serious failures as ‘having a release of greater than 100,000 m<sup>3</sup> and/or loss of life’ and very serious failures as ‘having a release of at least 1 million m<sup>3</sup> and/or a release that travelled 20 km or more and/or multiple deaths’. Both types show increasing tendency since the 1990ies (see Figure 2).

**Figure 2. Number of very serious and serious TMF dam failures by decades from 1960 to 2019.**

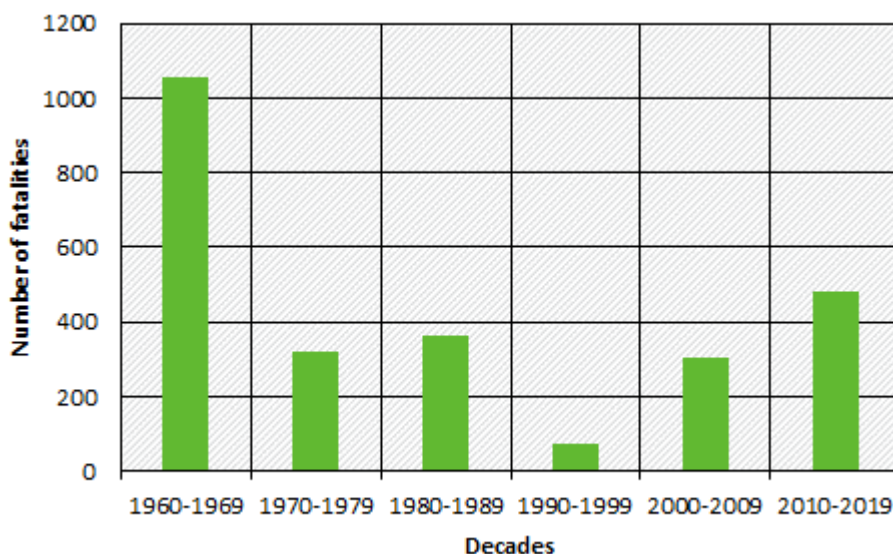
In the last 60 years, 2,599 deaths due to 323 accidents at TMFs have been registered (Figure 3 and Annex A). Across decades, the figures show that the loss of human life has significantly increased in the last 20 years. During the last 10 years, there were 480 deaths stemming from 13 TMF failures. In 2019 alone, 327 people died or are missing because of two accidents (dam failure in Brumadinho, Brazil: 259 people were killed and 11 are reported missing; disaster in

Loss of human life because of TMF dam failures stayed within the range of 300-400 in most decades (from 1990 to 1999 there was a significant decrease). From 1960 to 1969, a very high death number was recorded due to some very dramatic accidents such as the accident on Mir mine, Sgorigrad, Bulgaria in 1966, when half of Zgorigrad village was destroyed, killing 488 people (WISE, 2020).

**Figure 3. Reported human life loss because of TMF dam failures by decades from 1960 to 2019.**

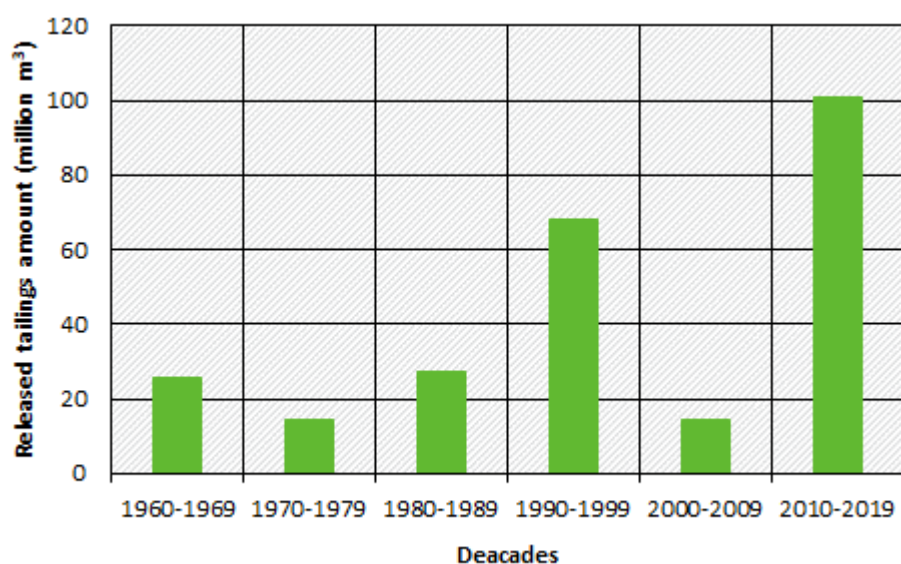
Looking at the last 60 years, a total of almost 250 million m<sup>3</sup> tailings materials in 323 TMF accidents were released (Figure 4 and Annex A, note that only about half of the accidents have recorded tailings release, the others either had minimal released amount or data are not available). In the last 10 years, the amount of released tailings has significantly increased, 58 TMF dam failures released more than 100 million m<sup>3</sup> of tailings into the environment.

**Figure 4. Recorded total amount of released tailings by decades from 1960 to 2019.**

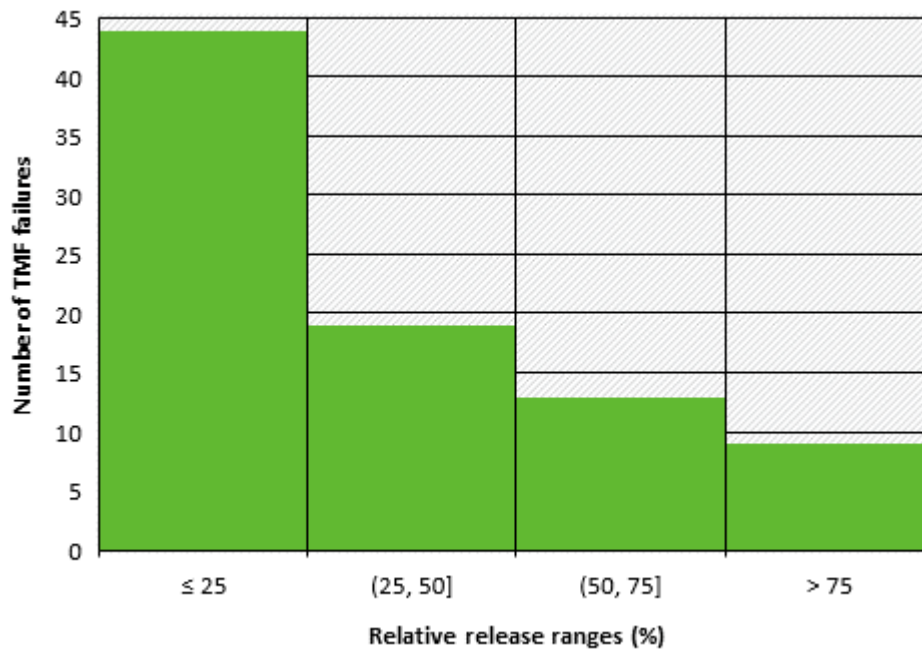
Out of the 323 TMF accidents, for which data were collected (see Annex A), only 85 cases contained data on the total capacity of the collapsed TMF together with information on the released volume of materials (see Annex B). The results of this evaluation are presented on Figure 5.

In most of the cases (44 of 85) the released volume was less than 25% of the total TMF capacity. The number of accidents where the relative volume of released materials ranged from 25 to 50% was more than two times less (19). The number of cases when spilled tailings volume reached a range of 50-75% and 75-100% of the total capacity was around 10 (13 and 9, respectively).

**Figure 5. Distribution of TMF failures according to the relative amount of released materials.**

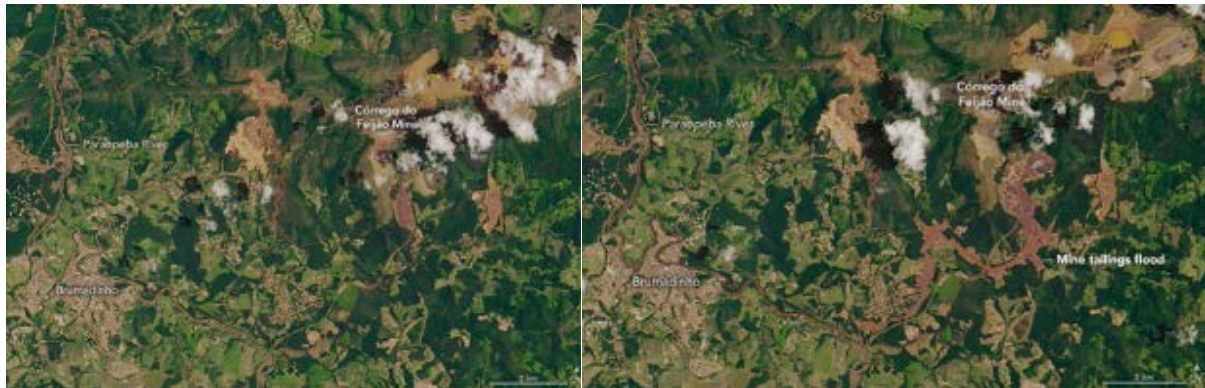
Paraopeba. The mud first hit the mine administrative area and a small community about 1 km downstream of the mine. The National Water Agency stated that the tailings had polluted over 500 km of rivers. The image analysis shows that the downhill runout distance was approximately 7 km after that the plume reached the river (Figure 6).

**Figure 6. Territory near the Córrego de Feijão dam on 14.01.2019 (left) and 30.01.2019 (right).**

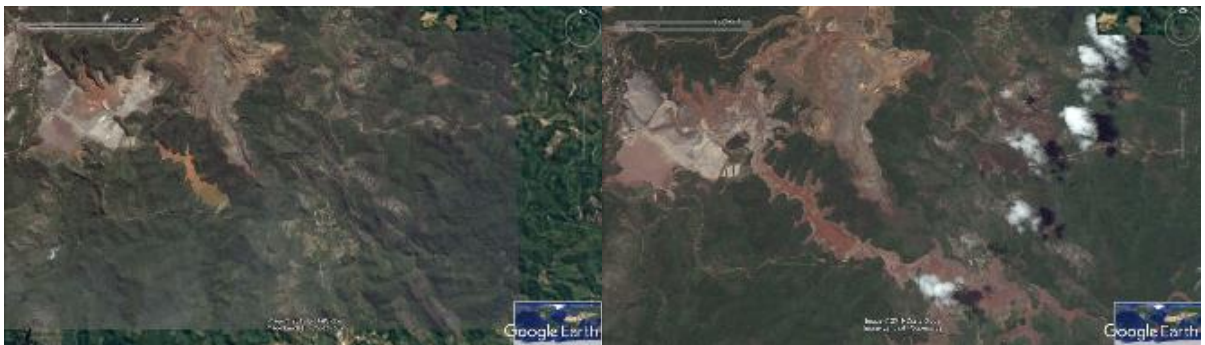
The failure on the Samarco Mineração S.A Fundão tailings dam on the 5th of November 2015 released tailings, which travelled downstream via a natural waterway. The mud continued to move further about 650 km along the Rio Doce River, reaching the Atlantic coast 17 days later. However, the image analysis of the accident (Figure 7) shows that the distance to the affected main waterbody is less than 1 km.

**Figure 7. Territory near the Fundão dam on 21.07.2015 (left) and 11.10.2015 (right).**

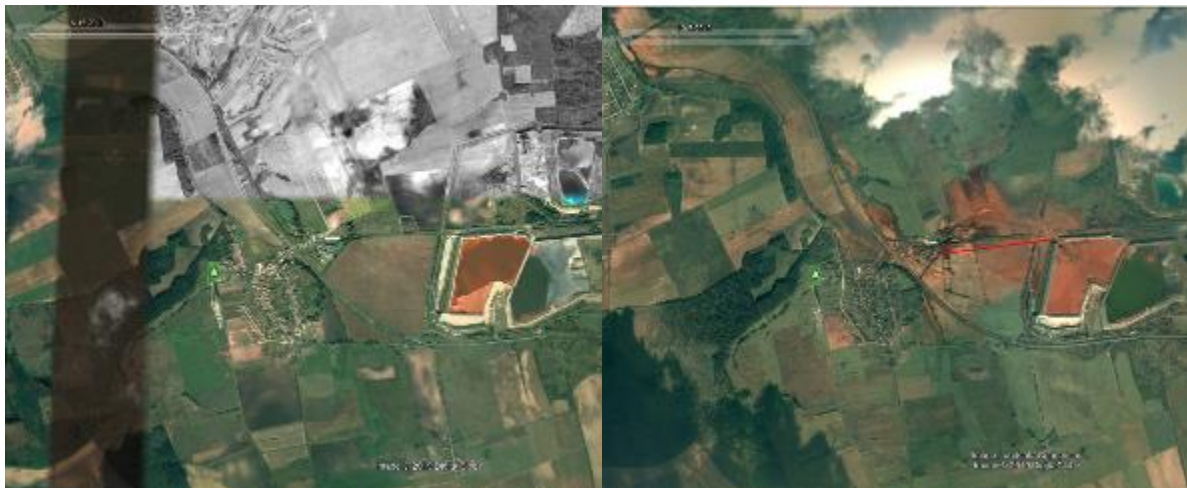
During a disaster near Ajka, the red mud reached the municipalities of Devecser, Kolontár, Somlóvásárhely, Somlójenő, Tüskevár, Apácatorna and Kisberzsény. An area of about 8 km<sup>2</sup> was flooded. In the following days, the red mud contaminated the Torna creek and the valley of river Marcal, almost reaching the river Rába. Through the Torna, Marcal, Rába and the Moson branch of the Danube, the alkaline red slurry travelled about 80 kilometres downstream and finally entered the Danube River. The image analysis (Figure 8) shows that the distance to the nearest settlement and surface water that were contaminated with the released tailings is about 4 km.

**Figure 8. Territory near the Ajka TMF on 07.10.2010 (left) and 22.10.2010 (right).**

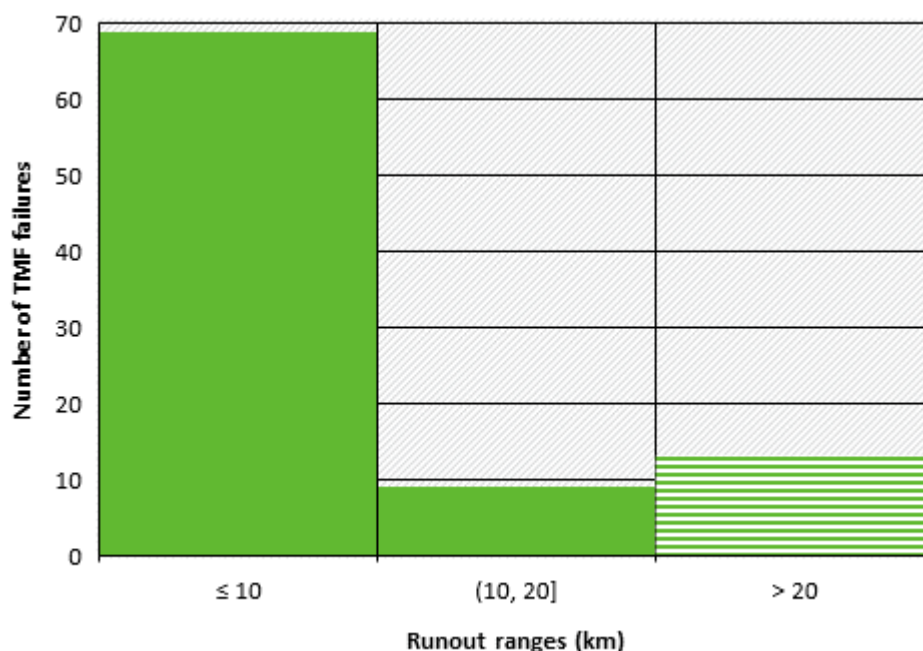
Updating the original runout distance data with the investigation results presented in Annex C, the amended overall runout length analysis shows that 69 cases out of the 91 reported accidents have less than 10 km direct runout distance (see Figure 9). Out of the remaining 22 cases, 9 have a runout length between 10 and 20 km, whereas 13 cases show a runout above 20 km. However, for all of these 13 accidents in-stream transport is indicated, thus, the direct runout distance needs to be further investigated. However, it is very likely that in 10 km distance the spill would reach a surface water body or the overland spread would slow down and the released materials would be retained in surface depressions and ponds, over flat areas, in vegetated surfaces or behind landscape objects or terrain barriers. Neglecting the 13 cases with incomplete information, the proportion of runout distances less than 10 km is almost 90% (69 out of 78). This indicates that a distance of 10 km could be a suitable threshold for delineation of a direct risk zone downstream of TMFs.

**Figure 9. Distribution of TMF failures according to the runout distance of the tailings.**

The striped column indicates data with uncertainty

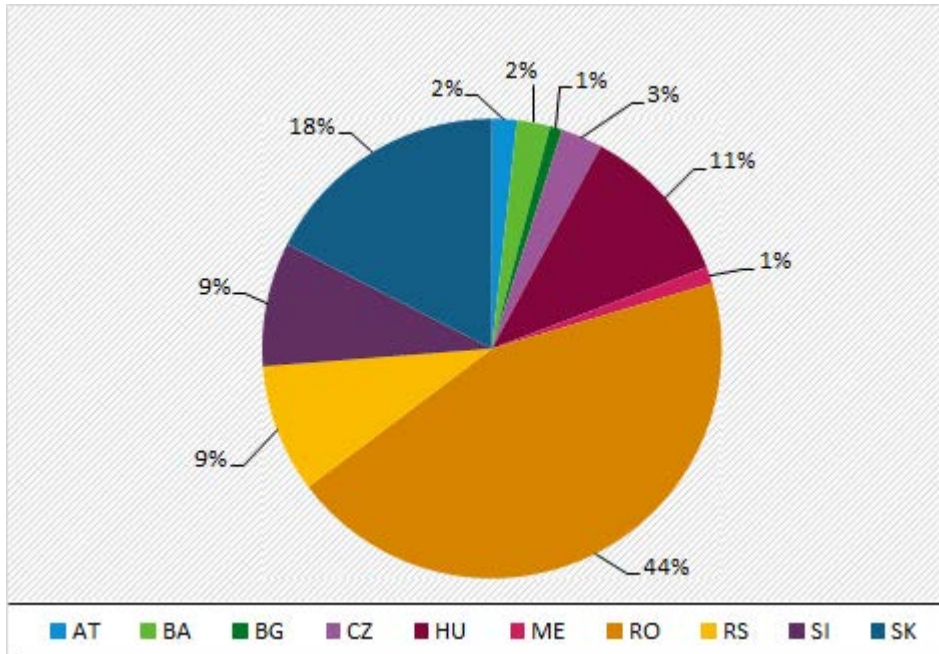
**Figure 12. Distribution of the TMFs over the DRB countries.**

Figures 12-16 demonstrate the distribution of all and active TMFs, the total volume of tailings materials and the average tailings toxicity over the DRB countries. The total volume of tailings materials in 343 identified TMFs (including 95 active TMFs) is more than 1500 million m<sup>3</sup>. Most of the identified TMFs (248 or 72%) are inactive, many of them were already rehabilitated or are currently under rehabilitation. The highest shares of TMFs in the DRB (Figure 12) belong to Romania (44%), Slovakia (18%) and Hungary (11%). Romania (29%), Slovakia (27%), Serbia (21%) and have the highest shares of active TMFs (Figure 13). The highest amount of tailings materials was evaluated for Serbia, Romania and Slovakia (Figure 14). Bulgaria and Serbia show substantial weighted average toxicity of the tailings at the national level (Figure 15). The average toxicity of tailings materials in Czech Republic also exceeds the DRB average because of two facilities that store radioactive waste. The average tailings amount is by far the highest in Serbia (Figure 16).

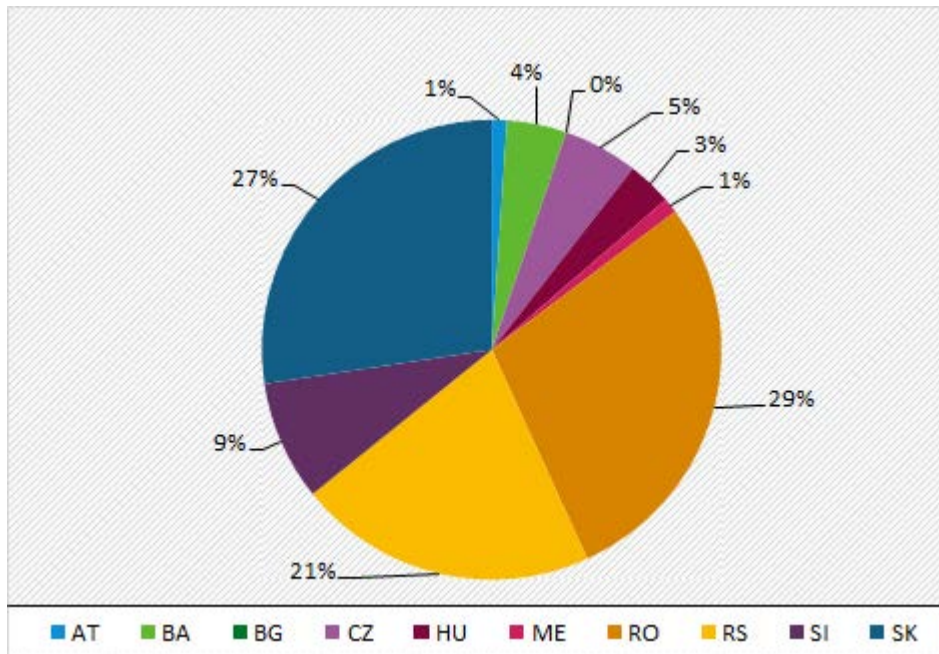
**Figure 13. Distribution of active TMF over the DRB countries.**

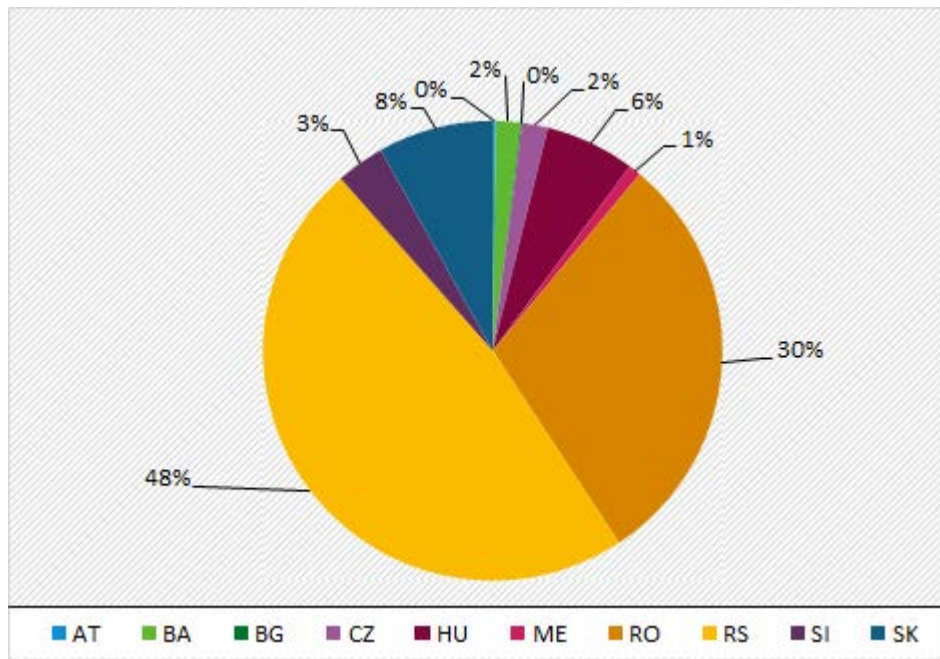
**Figure 14. Distribution of the total volume of tailings materials over the DRB countries.**

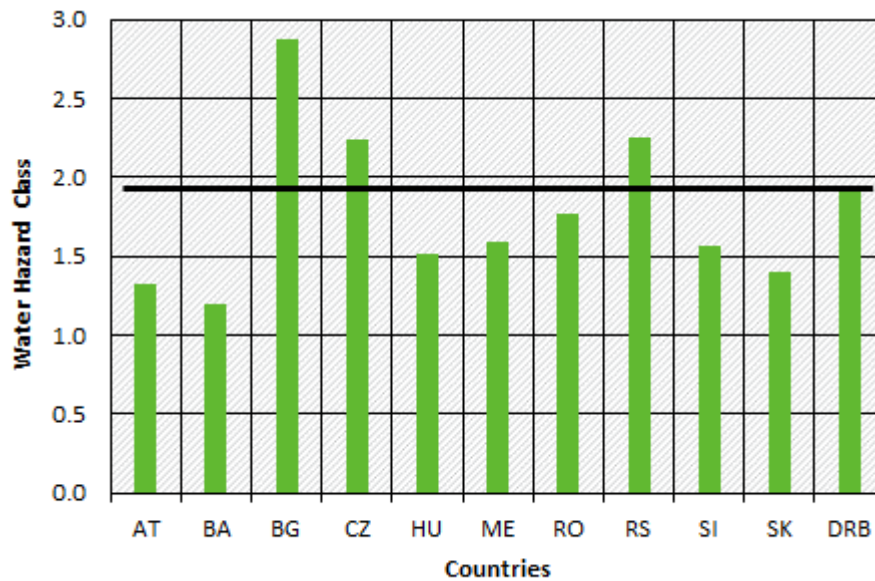
**Figure 15. Weighted average toxicity of stored tailings materials in the DRB countries.**

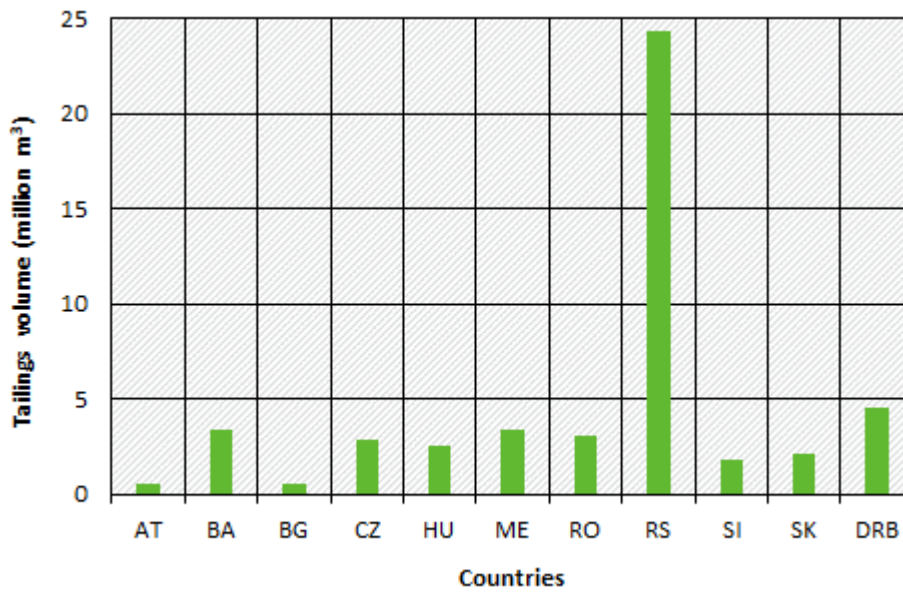
**Figure 16. Average tailings amount in the DRB countries.**

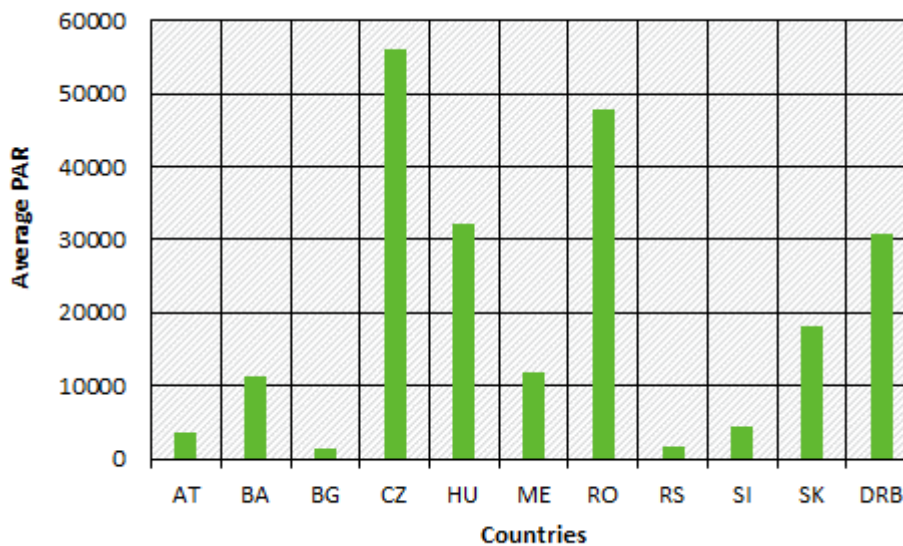
Figure 17 shows the average PAR associated to TMF risk zones in the Danube countries and in the DRB. Throughout the DRB, the average PAR per TMF is 31,000 inhabitants (note that multiplying this value with the total number of TMFs would overestimate the total PAR in the DRB since certain settlements are located in the vicinity of more than one TMF). The Czech Republic, Romania and Hungary have higher average PAR values than that of the overall DRB since in these countries several larger settlements can be found in the risk zones.

**Figure 17. Average PAR in the DRB countries.**

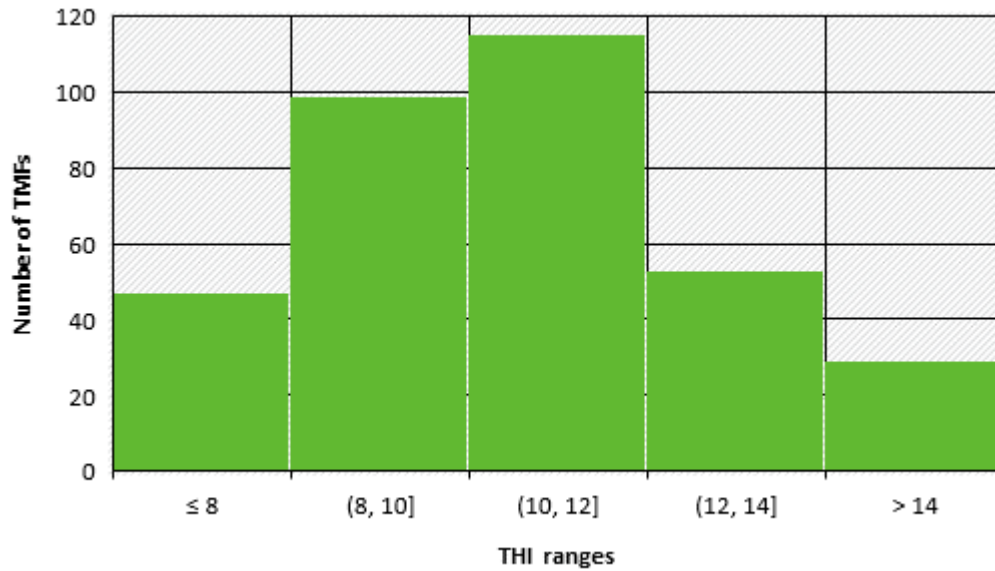
Figure 18. Distribution of the TMFs in the DRB according to THI.

Figure 18 demonstrates the distribution of the TMFs in the DRB according to THI ranges. In total, 146 TMFs have very low ( $THI \leq 8$ ) or low ( $8 < THI \leq 10$ ) hazard. Additional 115 TMFs have medium hazard ( $10 < THI \leq 12$ ), whereas high ( $12 < THI \leq 14$ ) and very high ( $THI > 14$ ) hazard was determined for 82 TMFs. Figure 19 shows the location of the TMFs categorized by hazard level.

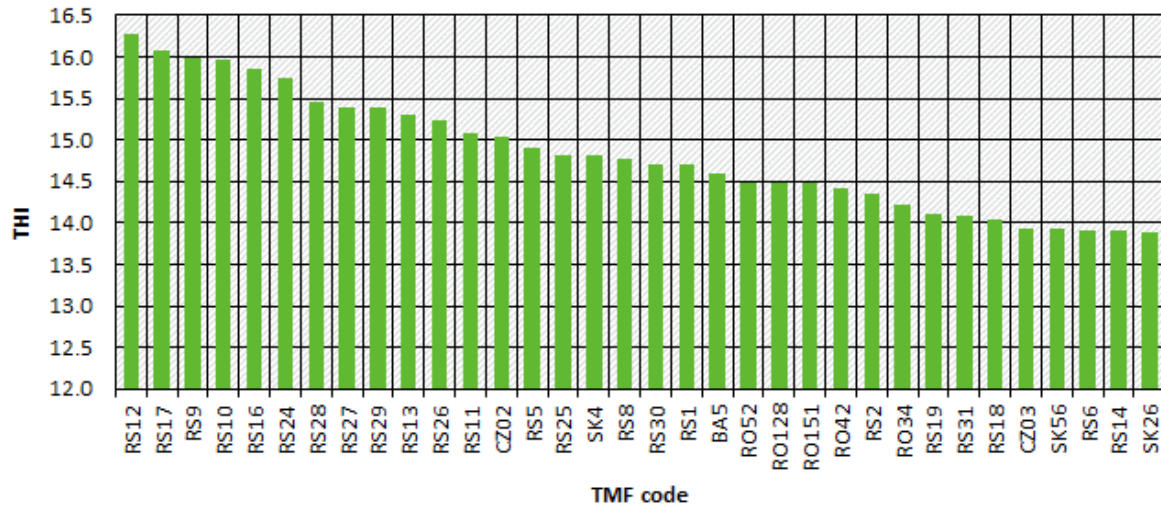
**Figure 20. Top 10% TMFs with the highest THI in the DRB.**

Most of top 10% TMFs with the highest THI values are located in Serbia (Figure 20). Out of the 34 TMFs, 23 can be found in Serbia, 5 in Romania, 3 in Slovakia, 2 in the Czech Republic and 1 in Bosnia and Herzegovina. The vast majority of these TMFs store slurry or sludge of non-ferrous and precious metal ore extraction with heavy metals as major contaminants. The TMFs in Czech Republic are ranked as quite highly hazardous because they contain radionuclides.

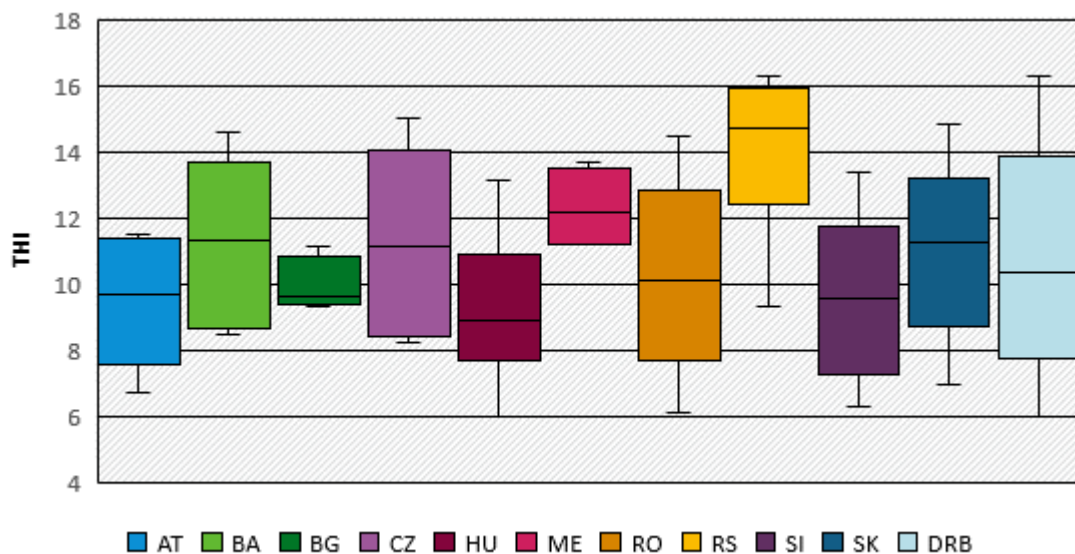
**Figure 21. Median, 10%-90% percentiles, minimum and maximum THI in the DRB countries.**

Preliminary assessment results for the DRB countries are presented in Figure 21. The median THI value for the DRB (10.4) is exceeded in Bosnia and Herzegovina (11.3), Czech Republic (11.1), Montenegro (12.1), Serbia (14.7) and Slovakia (11.2). Majority of the TMFs can be found in a relatively small upper range in Serbia and Montenegro. On the contrary, TMFs are spread around a low value in Bulgaria and Hungary. The country average values are the highest in Serbia, Montenegro, Bosnia and Herzegovina and Slovakia. The difference of 5 between the highest (Serbia) and lowest (Hungary) average THI indicates 100,000 times higher hazard.

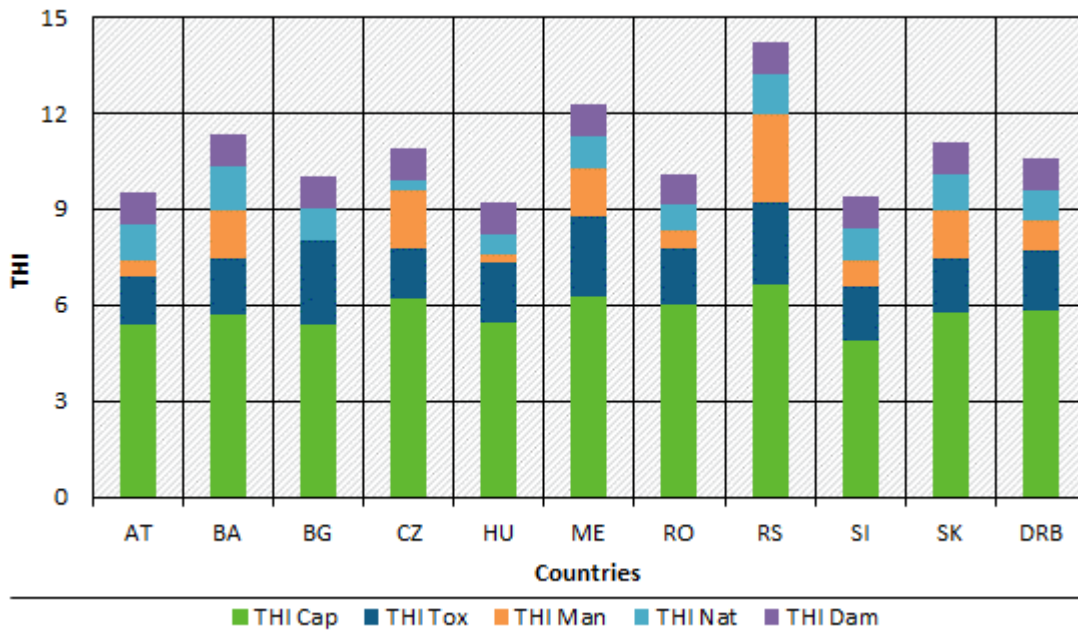
**Figure 22. Breakdown of the average country's THI in the DRB.**

Figure 22 demonstrates the breakdown of the average THI constituents for the DRB countries. The TMF capacity strongly dominates the hazard assessment, toxicity and management status related hazards have significant impact on the overall THI, whereas natural hazards and dam stability have minor influence. The hazard of dam failure was evaluated equally for all countries because no data were found or received on the Factor of Safety of the dams. The hazard of tailings toxicity is high for the TMFs in Bulgaria, Serbia and Montenegro. The hazard caused by TMF capacity is substantial in Serbia, Montenegro, and the Czech Republic.

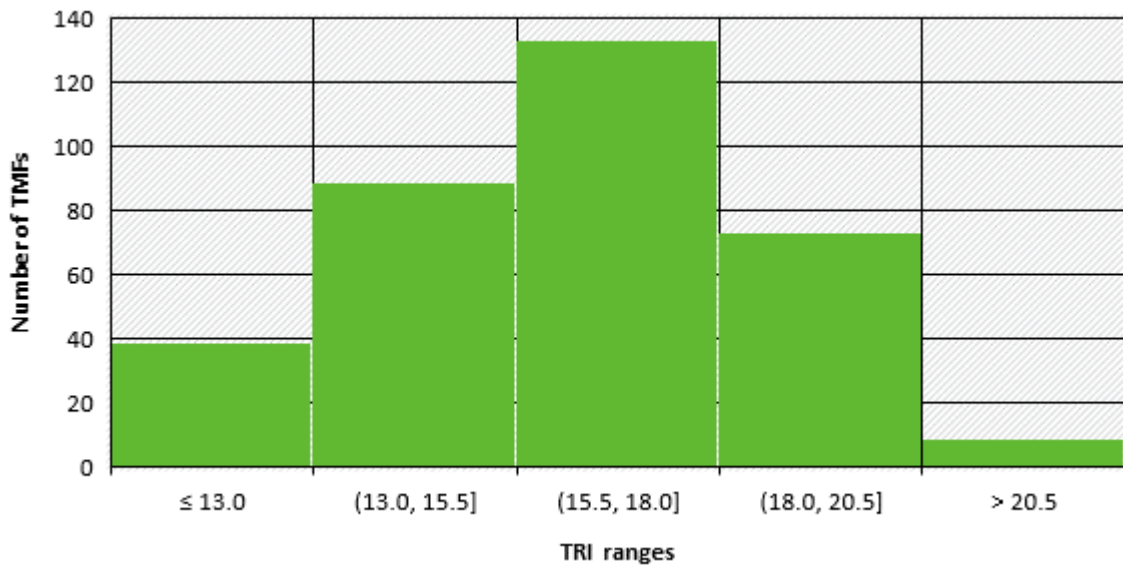
Figure 23. Distribution of the TMFs in the DRB according to TRI.

TMF distribution according to TRI classes (Figure 23) is similar to that of based on the THI. Very low and low risk was calculated for 128 TMFs, 133 TMFs have medium risk and 82 facilities show high and very high risk. A snapshot on the TMFs grouped according to the main TRI ranges is presented in Figure 24. The detailed online map can be found on the link: [https://www.google.com/maps/d/viewer?mid=11vS2CgbPEPPpW0j1\\_uAB\\_aemw9z03pf3&ll=46.16802179496559%2C20.8467&z=6](https://www.google.com/maps/d/viewer?mid=11vS2CgbPEPPpW0j1_uAB_aemw9z03pf3&ll=46.16802179496559%2C20.8467&z=6).

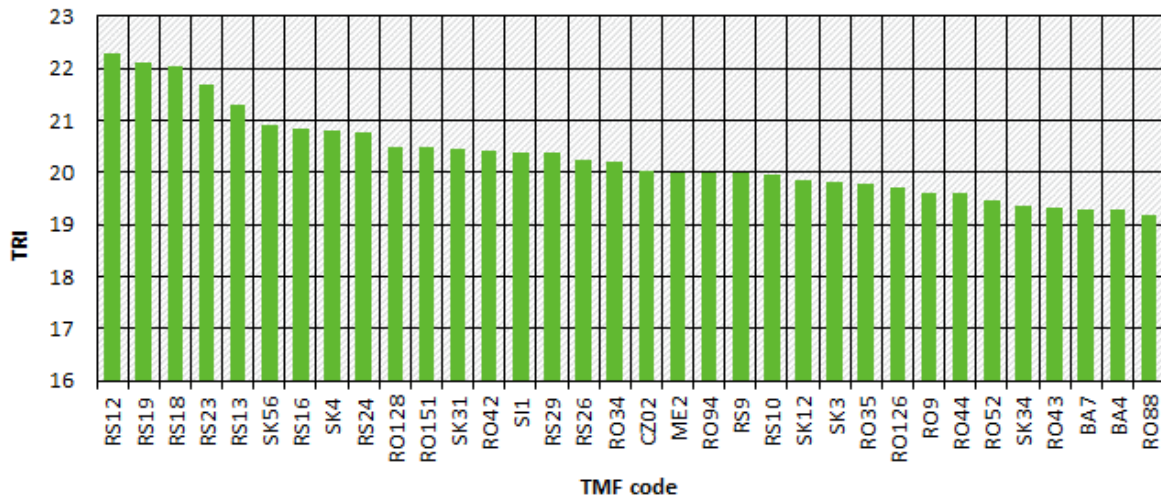
**Figure 25. Top 10% TMFs with the highest TRI in the DRB countries.**

Hotspots associated with the highest risk (TRI) are shown in Figure 25. The top 10% sites are dominated by Romania (12) and Serbia (11) but other countries are also present, making the TRI list more balanced in comparison to the THI top 10% list.

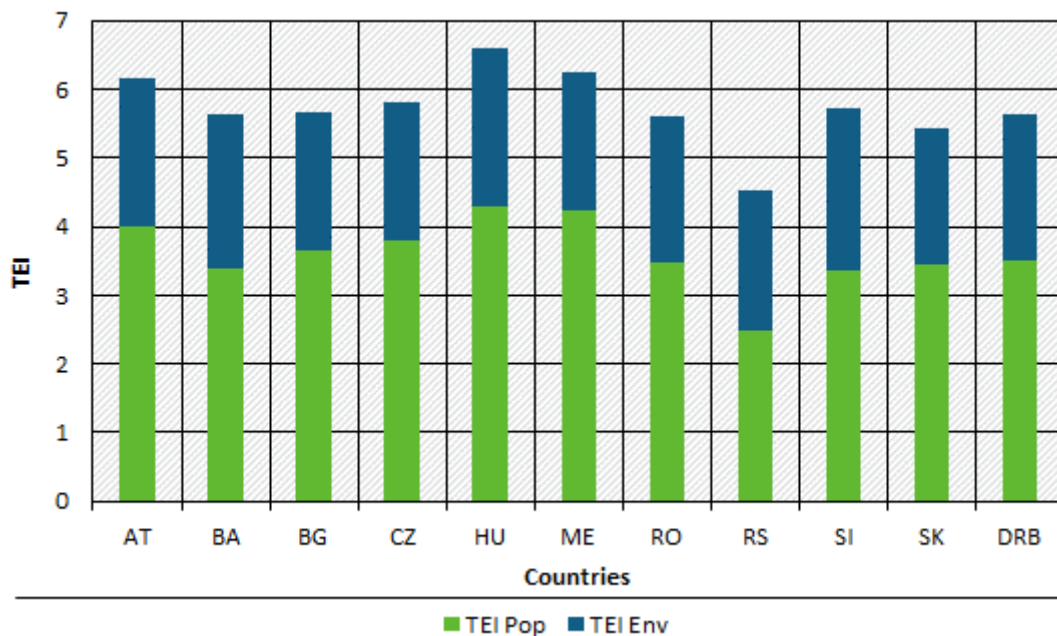
**Figure 26. Breakdown of the average country’s TEI in the DRB.**

Assessment of the average TEI of the Danube countries is presented in Figure 26. Potential population exposure is the highest in Hungary and Montenegro. Nevertheless, the differences between countries are rather small, except in Serbia, where mainly small villages or scattered houses are located in the risk zones. The environmental exposure is the largest in Slovenia and Hungary, but their exposure index values are in a very similar range compared to the rest of countries.

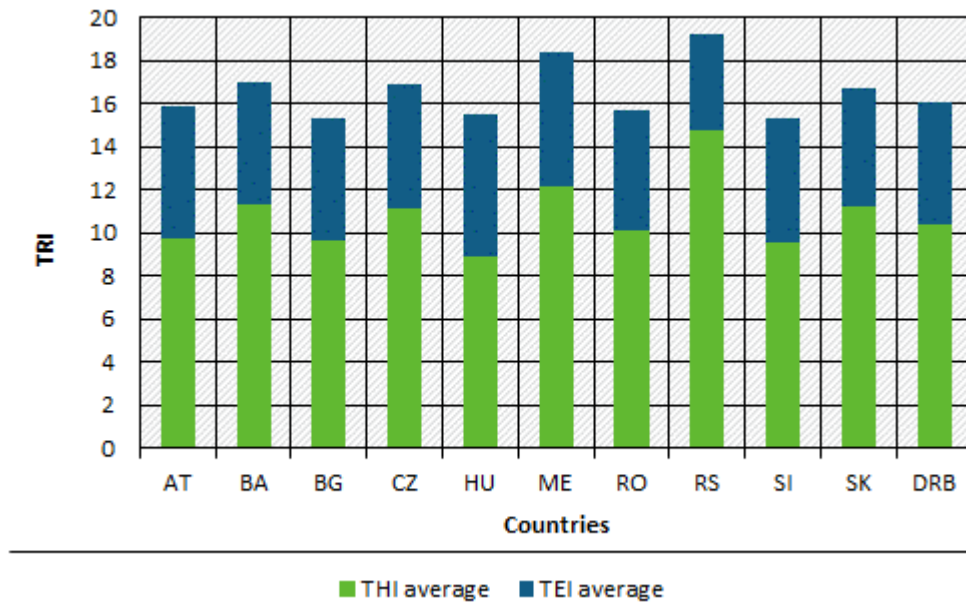
Figure 27. Average TRI values of the Danube countries.

The country average TRI values, the summed THI and TEI, are shown in Figure 27. Similarly to the THI, the TRI is the highest in Serbia and Montenegro, followed by Bosnia and Herzegovina, Czech Republic and Slovakia. The rest of the countries are below the DRB mean. The difference between the maximum (Serbia) and the minimum (Slovenia) is about 3.5, representing a risk 4,000 times higher.

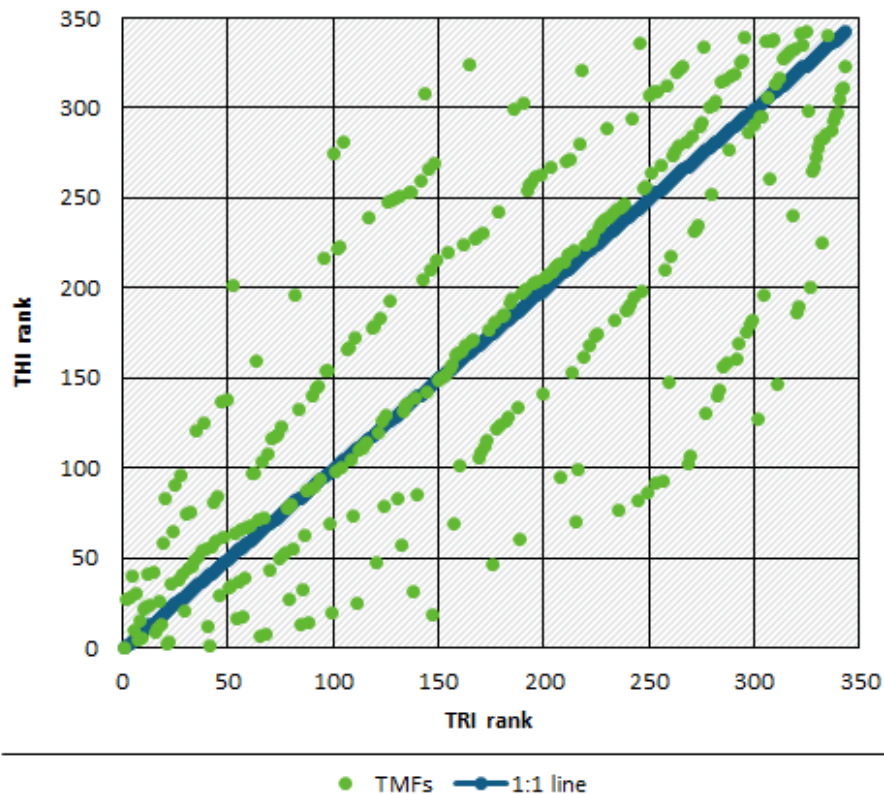
For each TMF, both the THI and TRI were calculated and ranked in the DRB. The preliminary ranks of all sites are presented in Figure 28. Blue dots indicate the TMFs according to their TRI and THI ranks, whereas black line represents completely identical rankings (no difference between TRI and THI).

Figure 28. Comparison of the preliminary THI and TRI values for the TMFs in the DRB.

For many TMFs, the blue dots are scattered close to the black line, representing similar ranking results for the two indexes. This is because the TRI includes the THI and for these cases the TEI value has less impact on the overall TRI. However, for a high number of TMFs the ranks based on the two indexes are significantly different, indicating the necessity of considering land-use planning aspects at the point when TMFs are prioritized. For these TMFs, the TEI has a major impact on the final TRI value. This is very apparent for the top 10% TRI list (34 TMFs), where 16 TMFs posing high risk to population and environment would have much lower priority if only hazard was taken into account, i.e. only the remaining 18 TMFs are on both top 10% lists. Moreover, for only 10 TMFs are the ranks similar (rank difference less than 10). The index values and ranks of the top 10% TMFs (sorted by TRI rank ascending order) are highlighted in Table 12.

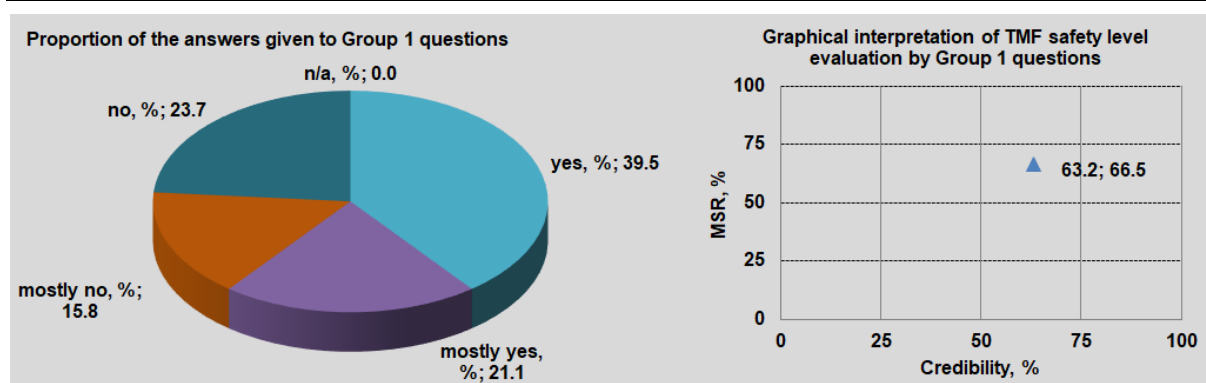
**Figure 29. Overall evaluation of the Checklist answers.**

Assessment results (distribution of the answers, MSRF and CRF values for the subgroups and the overall questionnaire) are automatically presented in summary tables and diagrams in the checklist tool (see Figure 29). They are automatically generated once all questions are answered.

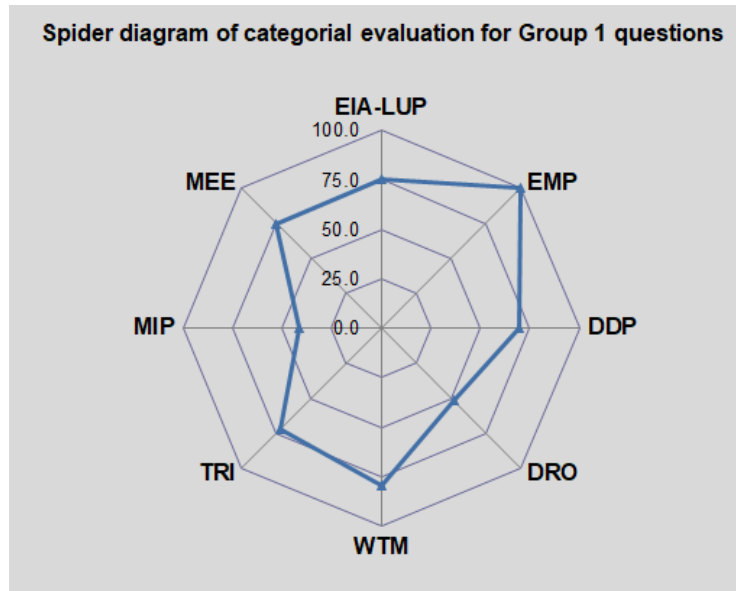
**Figure 30. Categorical evaluation of the Checklist answers.**

Assessment results (MSRF values by categories for the subgroups and the overall questionnaire) are presented in summary tables and spider diagrams in the checklist tool (see Figure 30). They are automatically generated once all questions are answered.

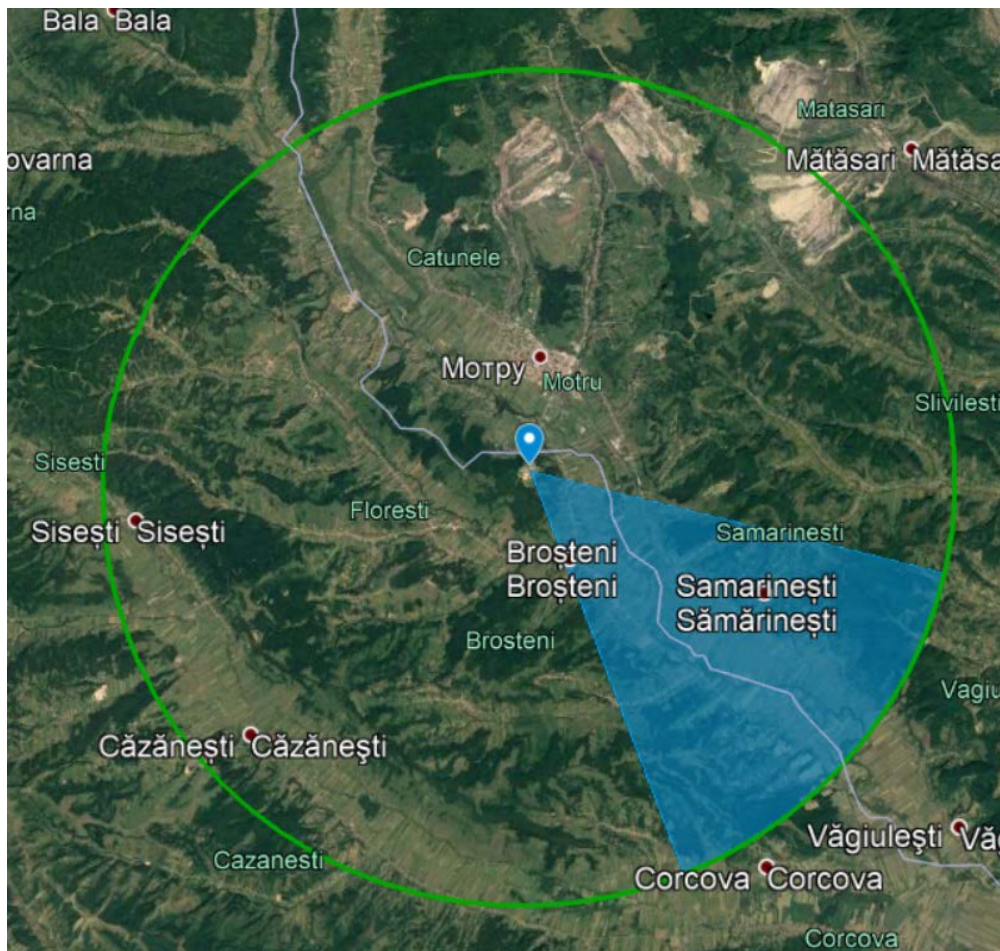
**Figure 31. Definition of risk zone downstream of the Motru TMF.**

The green circle outlines the potential risk zone (with 10 km radius) and the blue zone shows the downstream territory that can be potentially affected within the risk zone in case of an accident, © Google

Using Google Earth map the 10 km risk zone and the area downstream of Motru TMF were identified (see Figure 31). The settlements and water bodies at risk were determined by intersecting the downstream area with the risk zone.

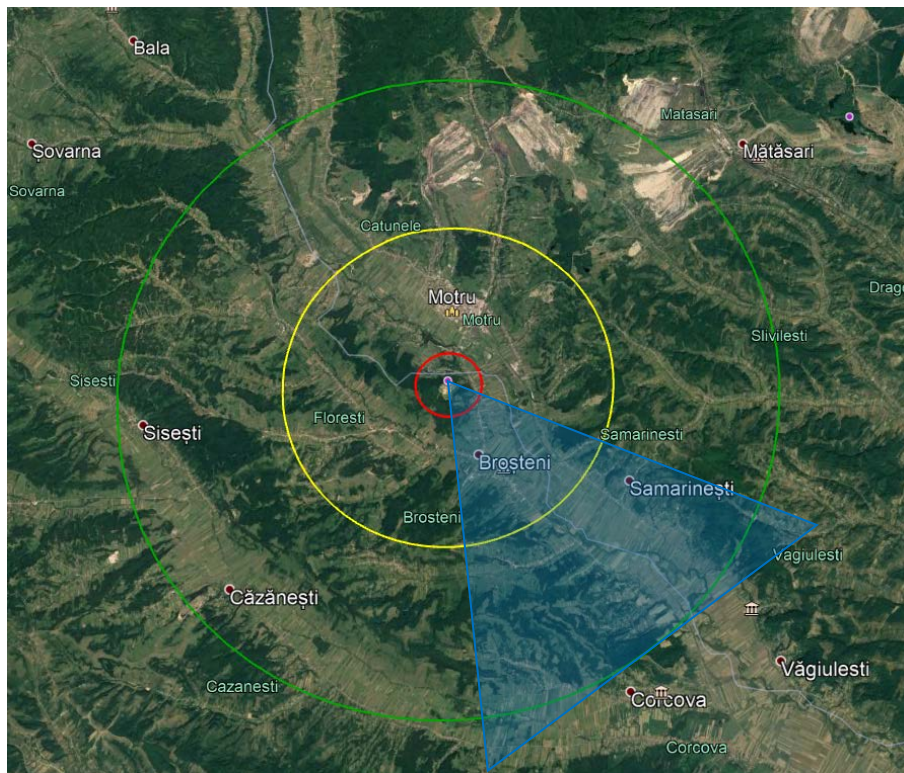
**Figure 32. Definition of different risk sub-zones downstream of the Motru TMF.**

The red circle outlines the risk zone I (0-1 km), the yellow circle outlines the risk zone II (1-5 km), the green circle outlines the risk zone III (5-10 km) and the blue zone shows the downstream territory that can be potentially affected within the risk zones in case of an accident, © Google

For the detailed risk assessment, the 10 km risk zone was subdivided into three sub-zones and the settlements and water bodies at risk were determined by intersecting the downstream area with the risk zones (see Figure 32).
